Manhole Inspection Summary

Manhole # S11S__016MH

Location Address: **710 S. Caton St**

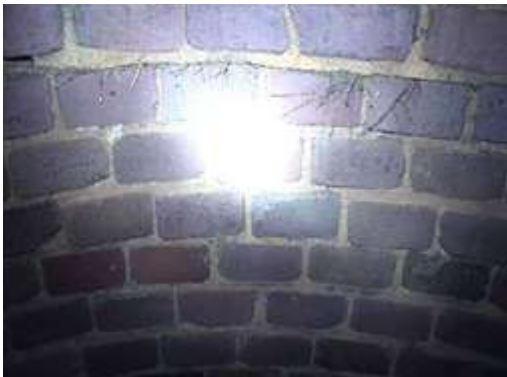
Misc

Condition: ☐ Sound ☐ Cracked ☒ **Root Intrusion** ☐ Loose Brick ☐ Deteriorated

Barrel Roots

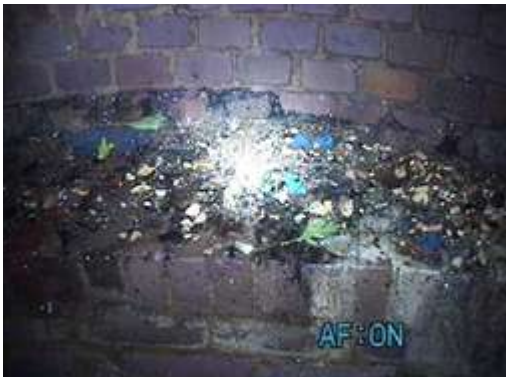
Misc

Bench Debris

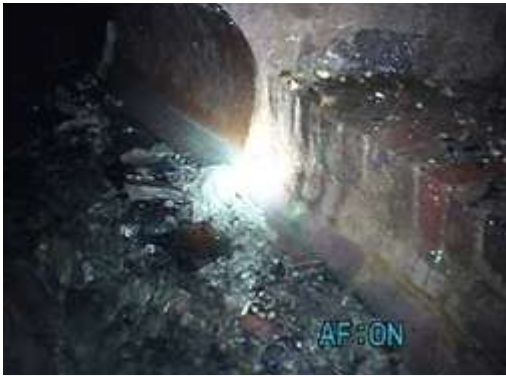
Defect 1

Condition: ☐ Sound ☐ Cracked ☐ Root Intrusion ☐ Deteriorated ☐ Leaks ☒ **Debris**

Channel Debris

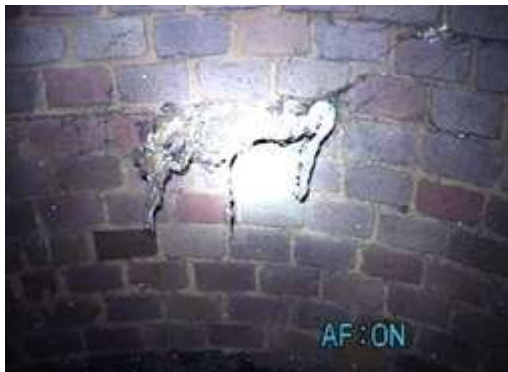
Defect 2

Barrel roots through mortar

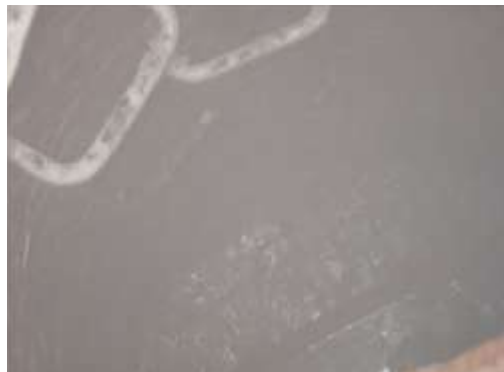
Defect 4

Steps Count: **13** Missing: **0** ☒ **Corroded**

steps corroded

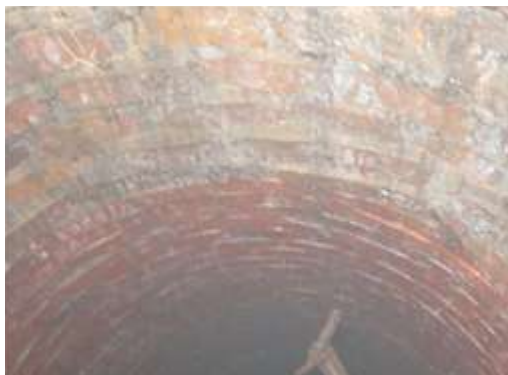
Defect 3

Infiltration: ☐ None ☐ Joint ☐ Cracks ☐ Mortar ☐ Roots ☒ **Wall**

chimney and corbel infiltration at walls

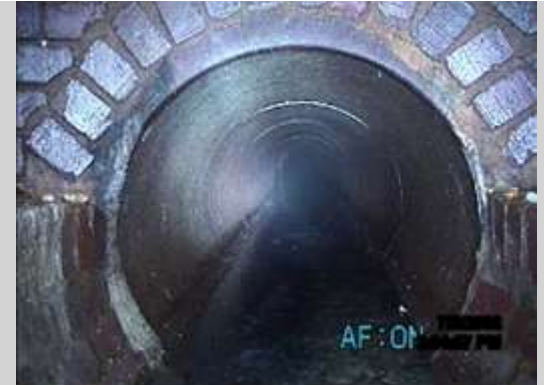
12 O'Clock Outflow

24 in. Circular Gravity Sewer
Pipe Out @ 12 OClock

Pipe Height: **25.2** (in.) Rod and Bar (Angled)
Pipe Material: **Clay** ☐ Pipe Lined
Invert Depth: **21.80** (ft.) Flow Characteristics: **Fast**
Deposits: ☒ None ☐ Mud ☐ Sludge ☐ Debris ☐ Grease
Silt Depth: **0** (in.) Deposits Extent:
Infiltration: **None** Pipe Seal Cond: **Sound**
